# BOSTON LIGHT: Preservation Guidelines and Stewardship Plan

Historic Boston Incorporated and

Massachusetts Department of Environmental Management

September 1990

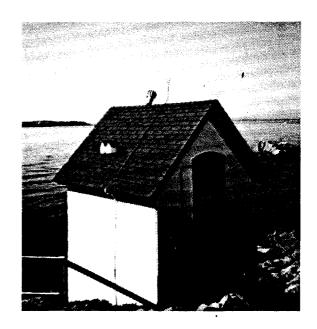
The oil house is a one-story brick structure, measuring 6' by 8', located on the south shore of the island. The roof is wood frame with red asphalt shingles (the framing exposed on the inside), the walls whitewashed brick, and the floor concrete. There are no gutters. There is a tall door opening with a transom, now filled with a solid panel, over the door. There is a recent metal ventilation hood in the roof, and a historic lightening rod and strap. The building is currently used for storage of paints and other flammable materials. A fire extinguisher cabinet is attached to the front of the building.
